SUMMARY REPORT:

**CHARACTERIZATION OF PARTICULATE
FOUND IN APARTMENTS
AFTER DESTRUCTION OF THE WORLD TRADE CENTER**

October 12, 2001

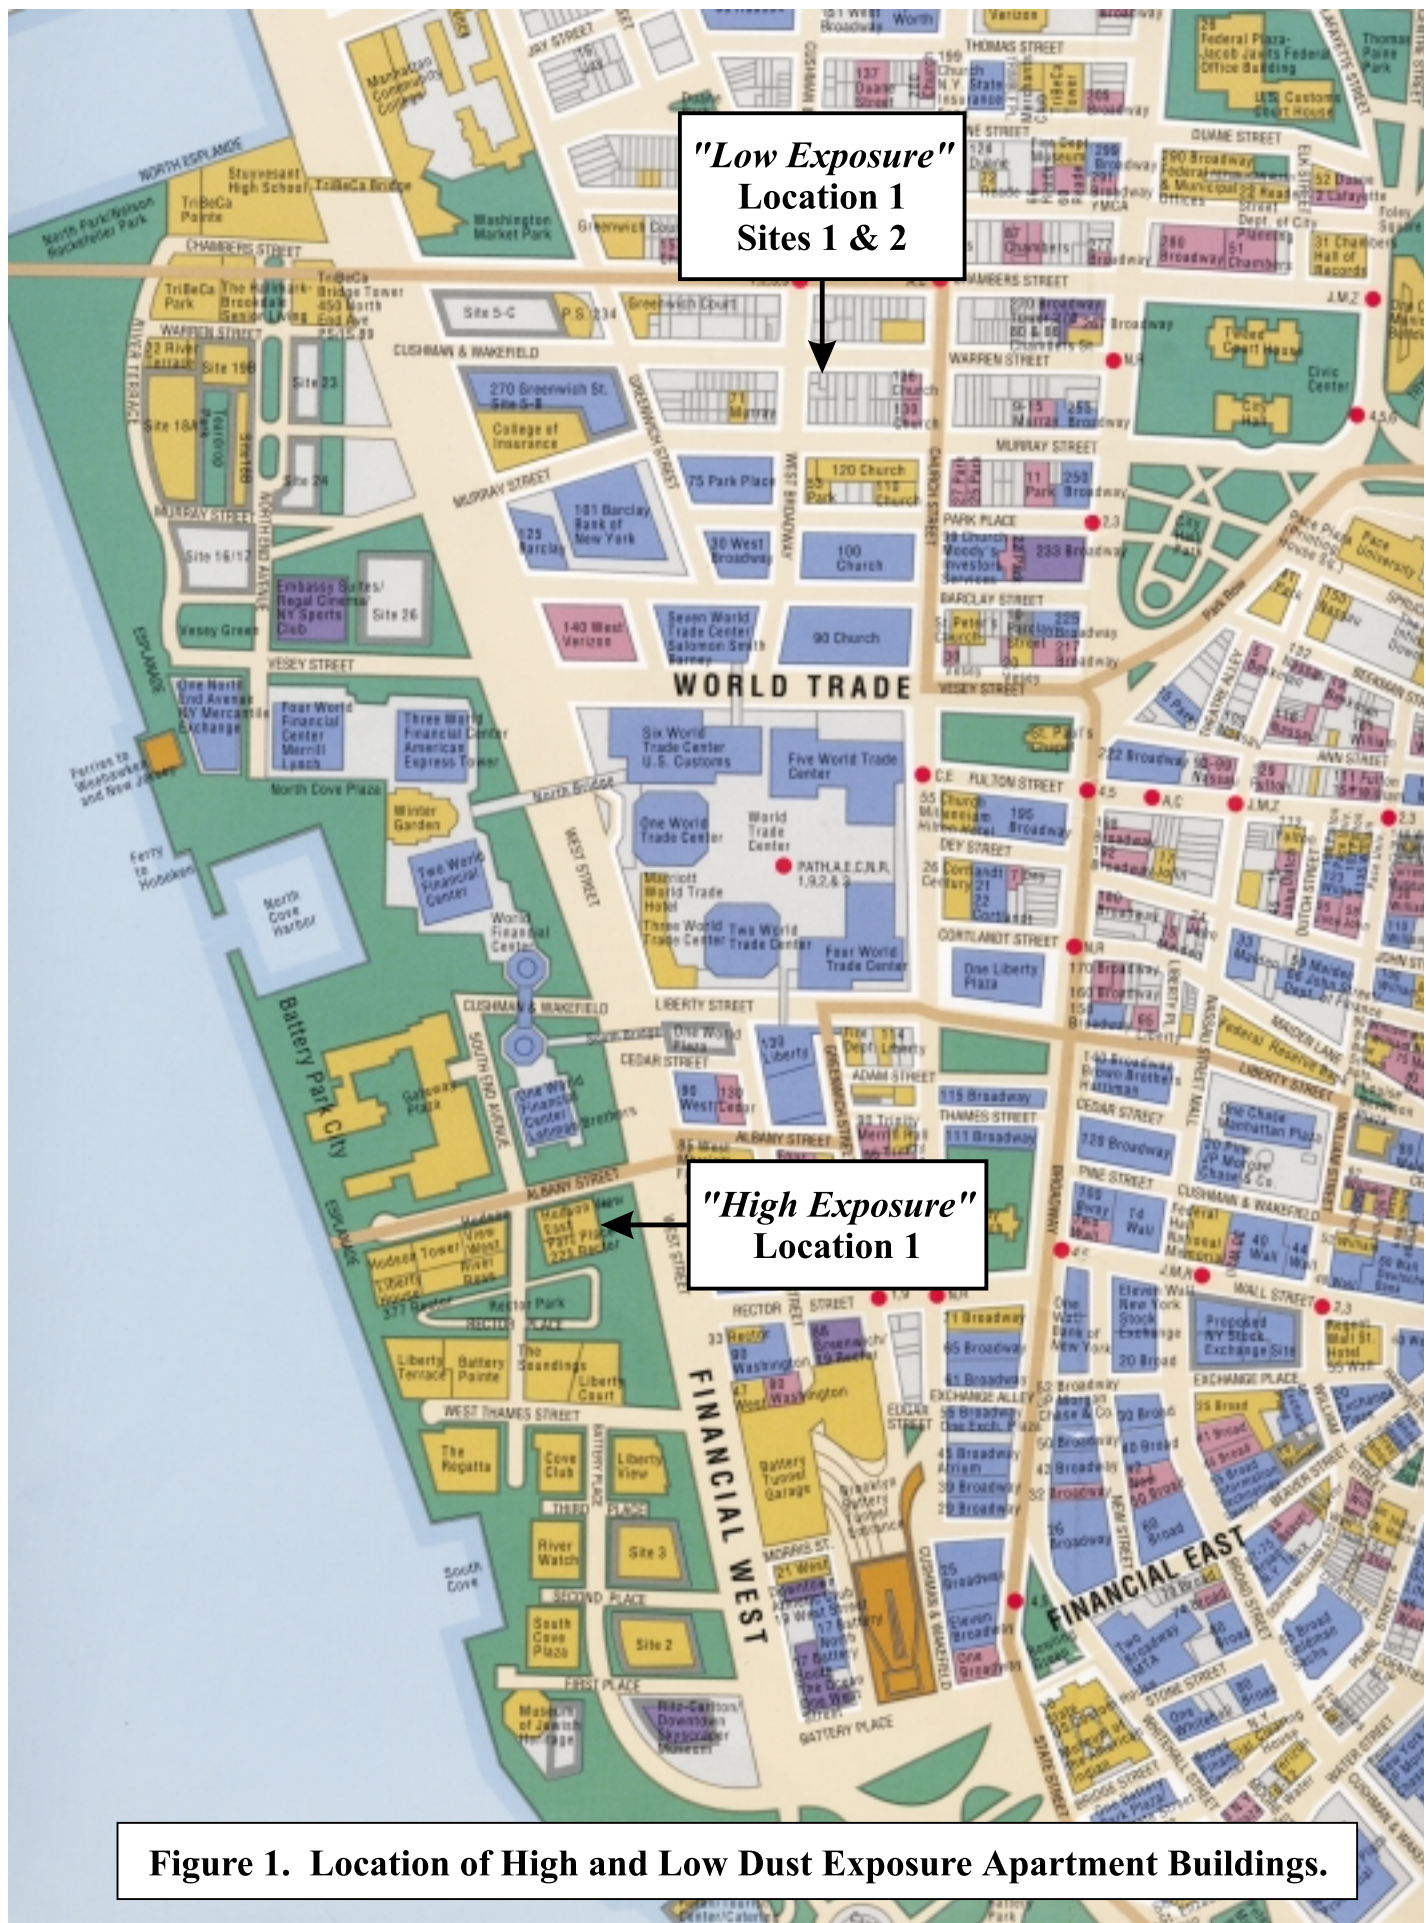
As shown in Figure 1, the high exposure 30-story apartment building is situated on South End Avenue, close to and southwest of Ground Zero. Windows of several apartments on the upper levels had been broken, but the building showed no other signs of external damage. This building was selected for study because it appeared to be the nearest one to Ground Zero that had electrical power available for operation of air sampling pumps. Apartment 10D on the

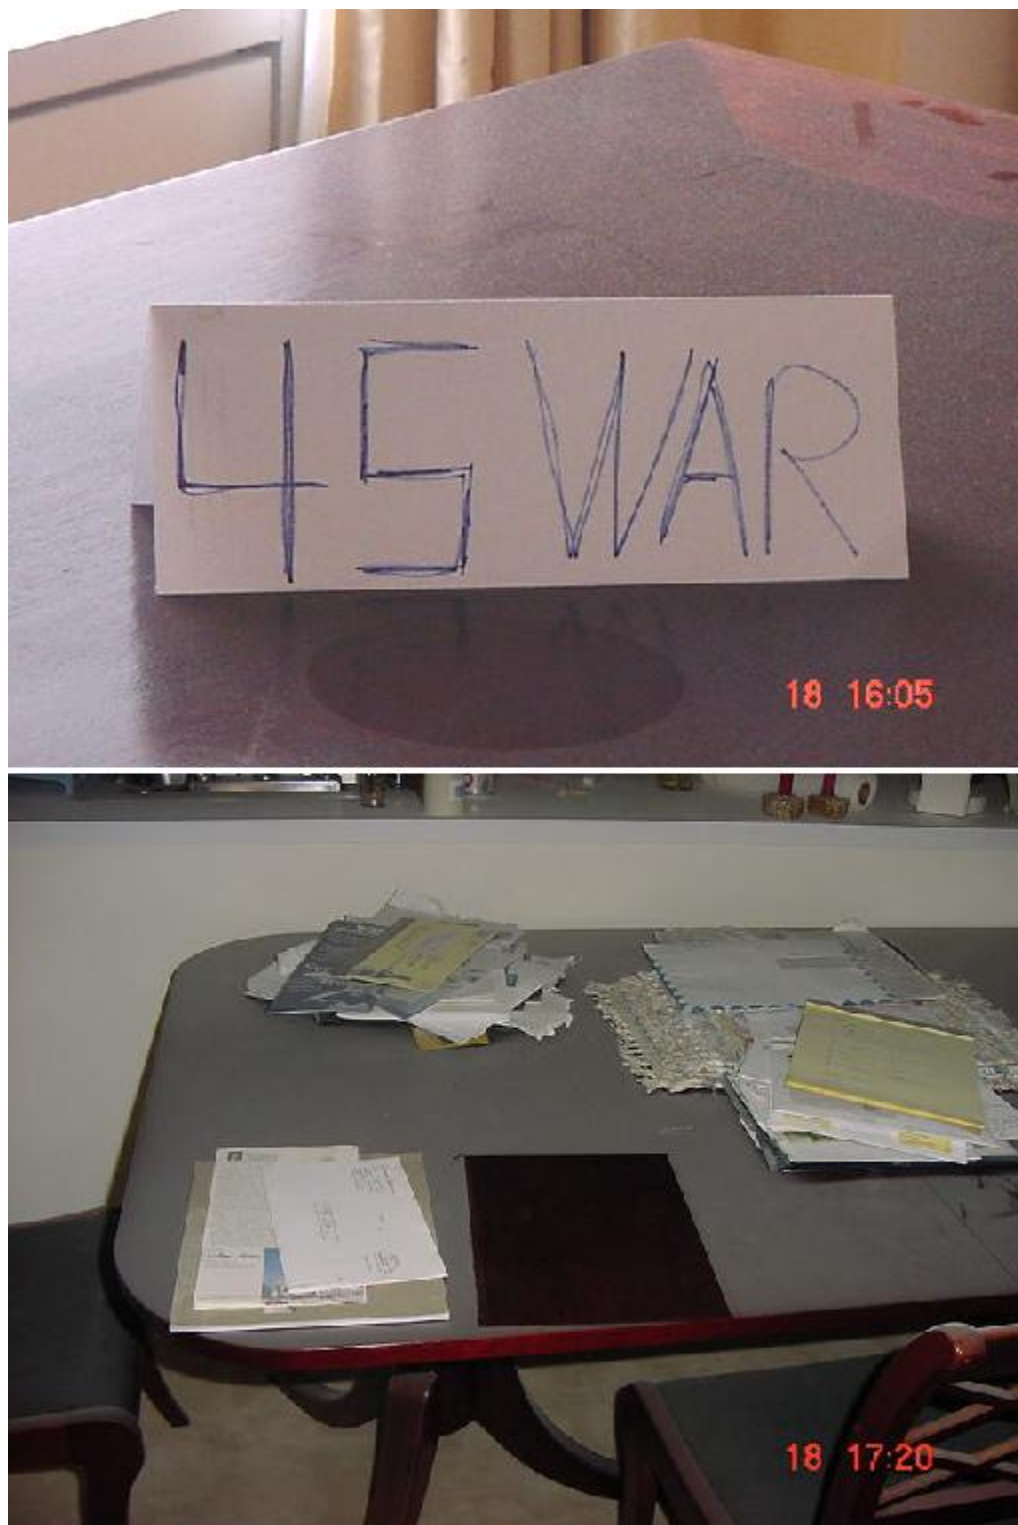
Figure 2. Dust Deposited on Furniture in Low (top) and High (bottom) Exposure Apartment Buildings.

All horizontal surfaces of Apartment 10D were covered by a thick layer of dust and debris that contained asbestos. It is important to take into account that the indoor air concentration results reported were obtained under passive sampling conditions with no active ventilation and minimum disturbance of the surface dust and debris. Disturbance of the dust by routine methods of dry dusting and vacuuming would significantly increase the airborne asbestos concentrations in the apartment. Based on the amount of visible dust and debris on surfaces in the apartment, the airborne asbestos could increase by orders of magnitude.

At 250 South End Avenue, a window had been broken and the hard surfaces of furniture were coated with a layer of dust and debris sufficiently thick that it could be swept up with a brush. A new toothbrush was first used to remove dust and debris from a known area of the surface, and the collected material was transferred to a plastic container, after which a wet non-woven cloth was used to collect the visible dust and debris that still remained on the surface. Sampling was conducted in accordance with ASTM D6480-99. Each wet cloth was stored in a plastic container.

The following recommendations can ensure proper cleanup of the asbestos-contaminated dust and reduce exposures of cleanup personnel and occupants returning to the building. Unless proven otherwise through testing, all dust should be assumed to be asbestos-containing.

- 1) The dust cleanup should be conducted by an environmental contractor with expertise in asbestos contamination cleanup or remediation of hazardous materials. Contractors selected for this work should be licensed by the proper authorities in the City of New York and/or the State of New York for asbestos or hazardous material cleanup activities. Individuals working for these companies should be properly trained by completing asbestos training courses certified by the New York State Department of Health and licensed for asbestos activities by the New York State Department of Labor. In lieu of this requirement, at a minimum, individuals should have Awareness Training in accordance with the OSHA Asbestos Standard, 29 CFR 1926.1101. The training should cover the potential exposures (such as asbestos and caustic irritant dust) that may be encountered during the activities, appropriate personal protective equipment, and work practices.
